Testing Times

Issue 15

December 2002

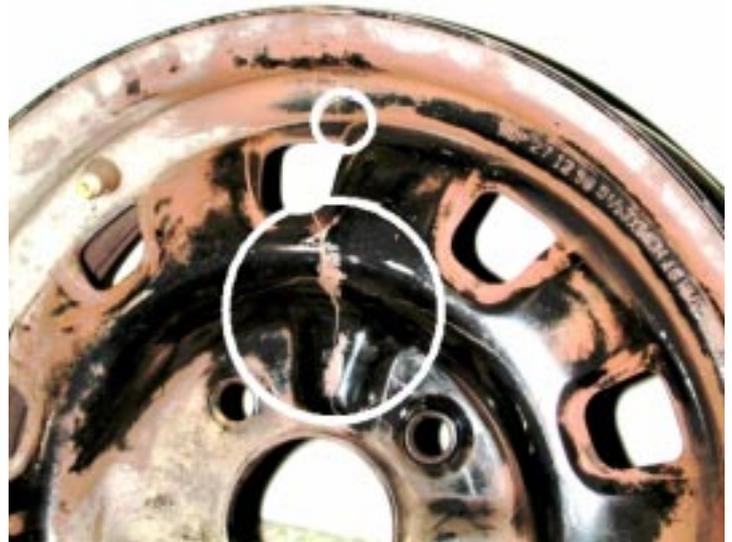
On this same subject, there appears to be a serious problem with too much wheel flex on the current Hyundai Sonata. At least one example has come to light of a wheel that has cracked badly as can be seen in the photo below

There are no signs of abnormal use or abuse suggesting that the cause is a design or manufacturing problem. Again, keep your eye out for it and if you see any examples of this sort of failure let your LVT supervisor know.

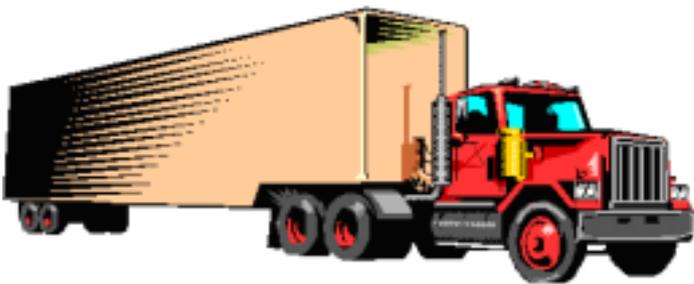
So how do you check that the protection system, whatever it is, works? Pulling out the trailer air or vacuum couplings and testing the tow vehicle brakes is no good as many couplings are self-sealing anyway.

What you need are suitable couplings (preferably with a short piece of open ended hose attached for ease of handling) that you can plug into the tow vehicle couplings (supply and control) to simulate broken lines. Once these are plugged in with the engine stopped and all air flow has stopped (other than the small bleed flow if a tractor protection valve is used) check that the tow vehicle's brakes do actuate properly.

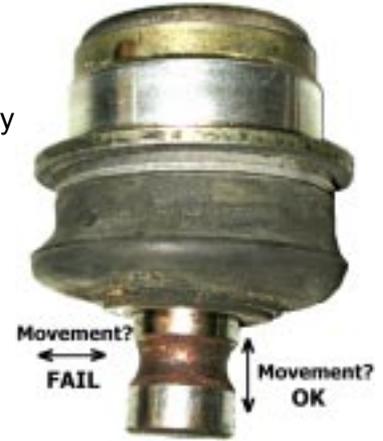
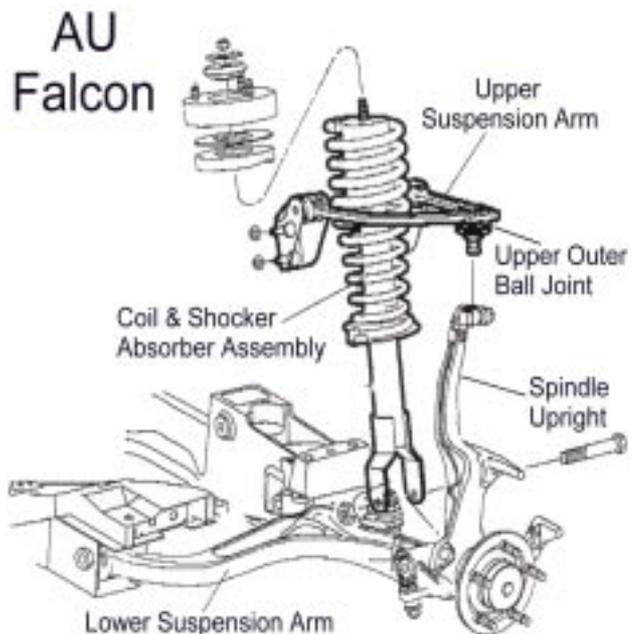
vertical movement look at the diagram below and consider how the units are installed. They are simply pressed in from under the suspension arm. A flange stops them being pushed right through and friction stops them possibly working back out. The upper control arm simply restrains the spindle upright in the horizontal plane. All vertical loads are carried by the lower control arm and the coil/shock absorber assembly and this assembly also provides the upper and lower bump stops.

While all parts are in position, even with the suspension on full droop (when the vehicle is on a body hoist) there is no significant vertical load on the upper ball joint.

Provided the horizontal free play of the ball joint is within specification (according to Ford - no perceptible horizontal movement only) vertical free play does not constitute a safety problem and should not be cause for rejection. By the time the upper ball joint is worn to the point that there is a risk of it separating there will be obvious horizontal free play.

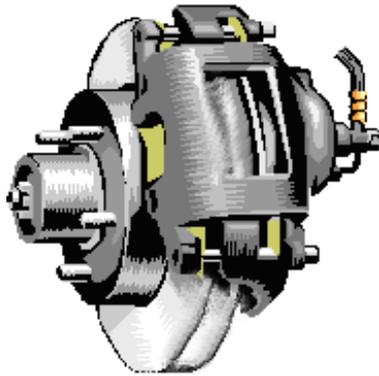
The rear brake disc rotors on the EA Series I Falcon start out at 15mm new and have a minimum thickness of 14mm (marked on the rotor) while the Series II start out at 13mm with a minimum of 12mm. All other parts of the rear brake system are identical.

The question is, "When the vehicles are virtually identical, why should you reject the rotors on a Series I at just less than 14mm thick when they are still thicker than brand new rotors on a Series II?"

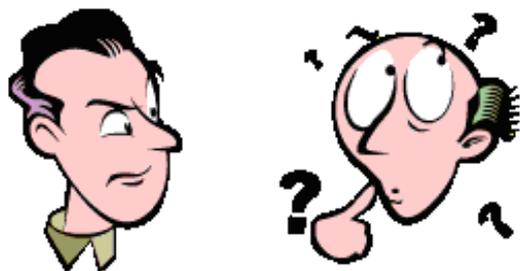
What do you say to the vehicle owner who knows that the Series II rotors can go down to 12mm but you reject his Series I rotors at 13.5mm?

You simply point out the minimum thickness marked on the rotor and tell him you cannot over-rule the person who authorised that marking to be put there. This is a very good reason for sticking to the minimum thickness marked on the rotor rather than using the workshop manual. Also you could get caught out badly (at least in a legal sense) if you passed 12.5mm thick rear rotors on a Series II on the basis of the workshop manual figure, if that vehicle had Series I rotors fitted and marked with a minimum thickness of 14mm.
