Surveyor Struck by Traffic Management Truck

Safety Alert

May 2015

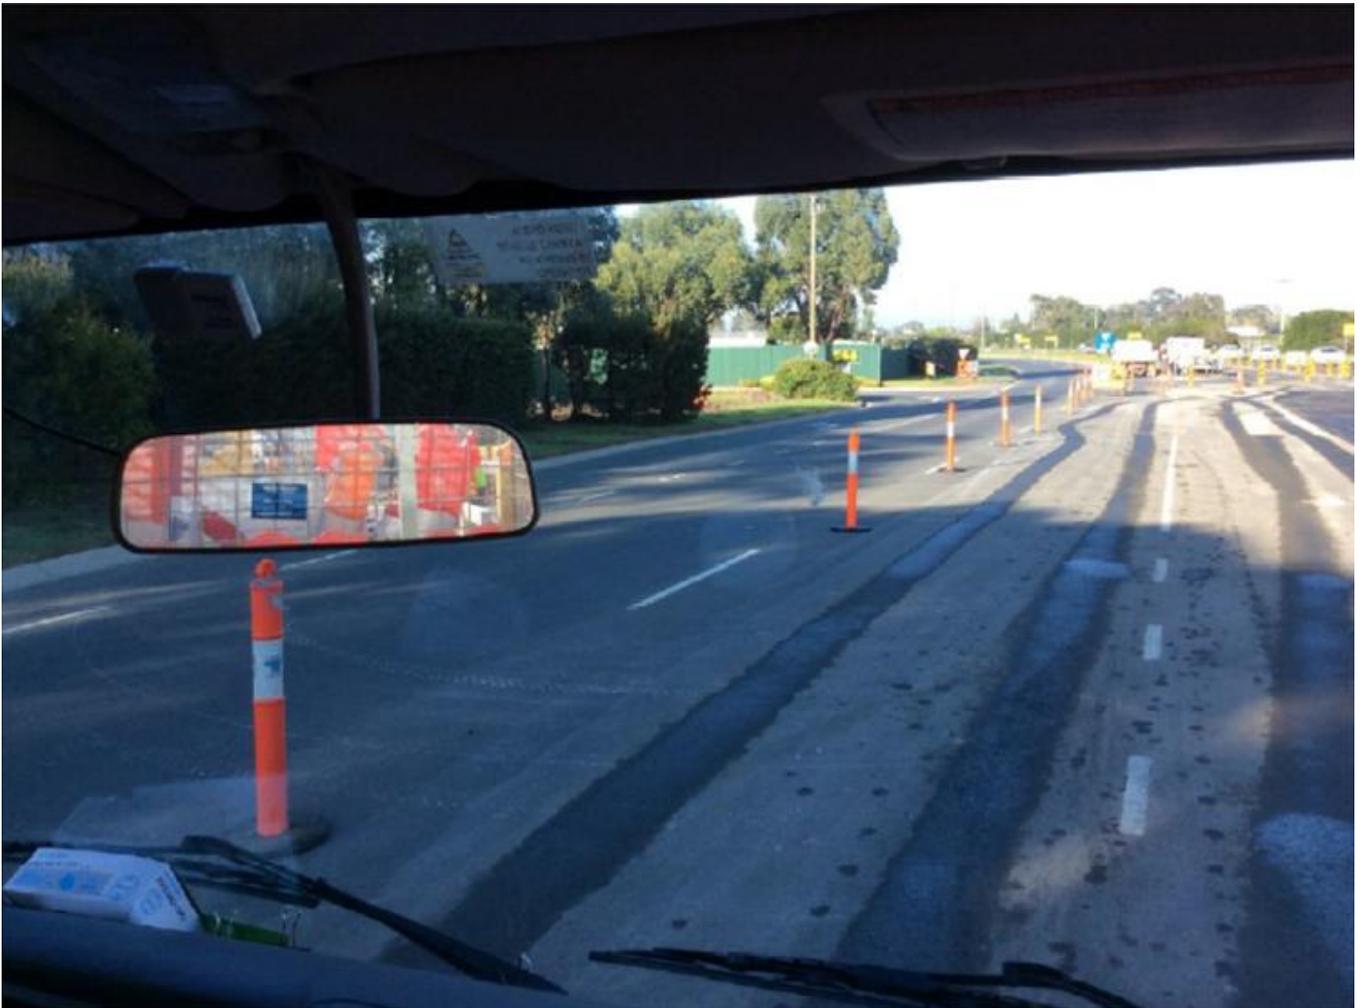
Rear view mirror from driver's seat

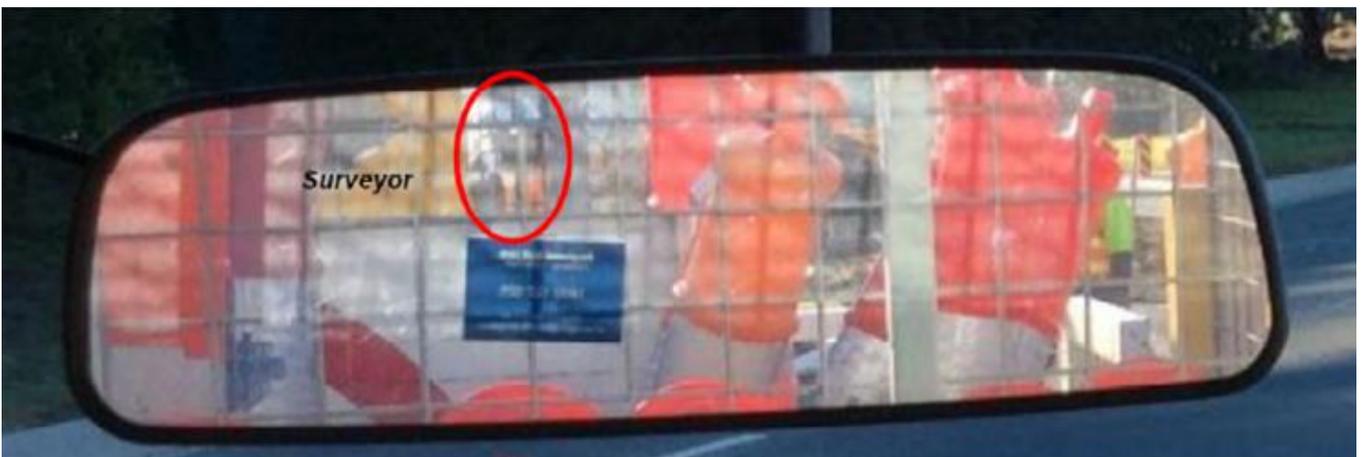
- **Restricted vision on traffic management trucks and similar vehicles needs to be addressed.** The operator of the truck had limited visibility in the rear view mirror and could not see the surveyor in the side mirrors. Additional devices should be considered such as reversing cameras, sensors, internal alarms or automatic brakes;
- **Workers and other pedestrians potentially putting themselves in the line of fire of vehicles and mobile plant.** If the surveyor involved had made positive communication with the truck driver, the driver would not have reversed without ensuring the path was clear; and
- **The potential noise being emitted from traffic passing** the lane closure may have reduced the effectiveness of the reversing alarm. This aspect is being investigated.

Visibility in rear view mirror

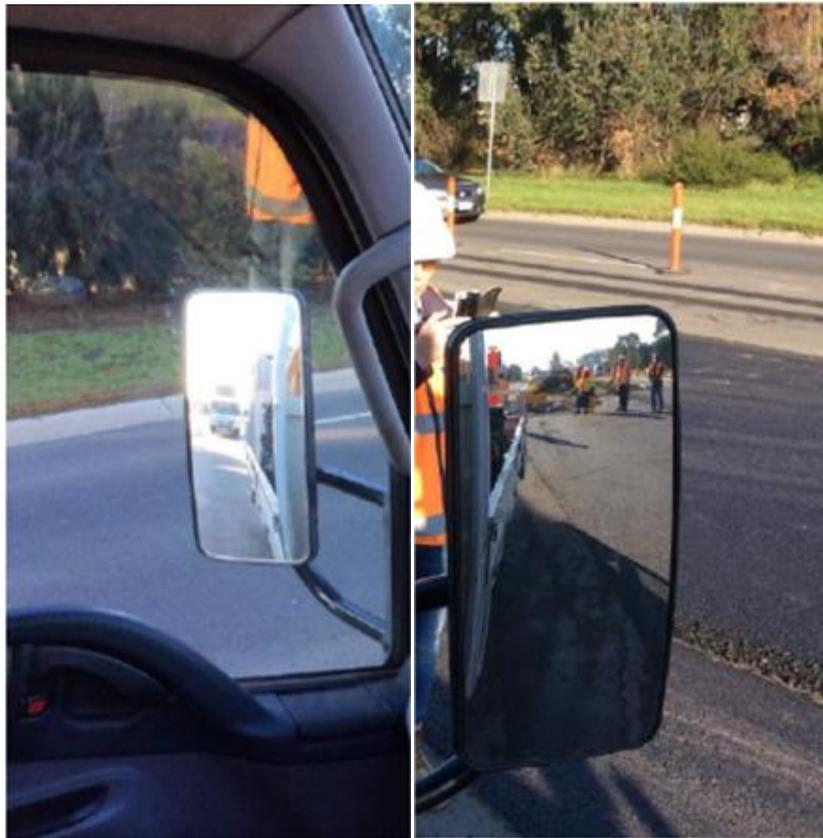
- The restricted vision from the truck didn't allow the driver to see the surveyor prior to reversing;
- The surveyor moved into the line of fire behind the truck to measure the control point; and
- There was no communication between the surveyor and the truck driver.

View from RH and LH mirrors- surveyor not visible due to blind spot

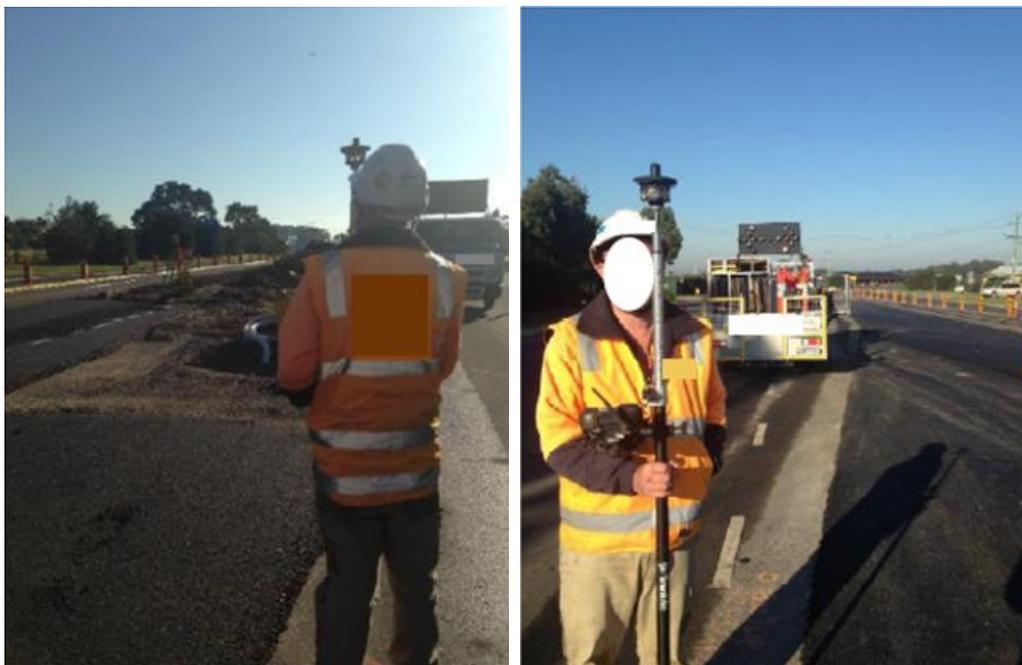
A surveyor was recently reversed into by a traffic management truck on a road construction site. The truck was reversing slowly but the external reversing alarm was not heard by the surveyor until very close. He shouted to the driver as well as jumping clear, but contact was still made, fortunately without serious injury.

Position of surveyor and truck prior to incident
