TREATMENT OF FLUSHED SURFACES USING HIGH PRESSURE WATER

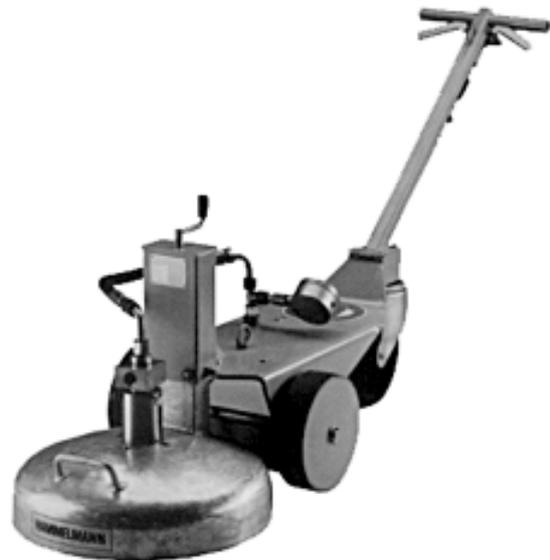
“Hydromower” - Hammelmann. Aquablast Type FR 1000

The equipment currently available consists of a “hydro mower type” apparatus which is manually moved over the area to be treated. Approximately one metre width is treated by a single pass of the apparatus. The high pressure water is discharged through two or more jets located on a rotating disc beneath the “hydro mower type” apparatus. The applied water pressure can be adjusted to control the amount of material removed from the surface of the pavement.

The process leaves a “slimy” like residue (a mixture of the bitumen, oil, grease and other grime) which needs to be swept/washed off the surface and disposed of responsibly.

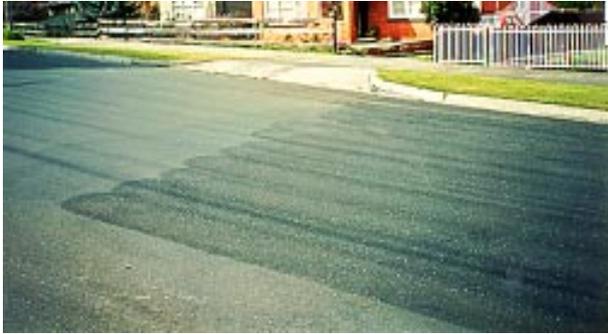
This asphalt area was treated by hydro jetting in 1991 to remove the surface mastic of bitumen and fine material to

improve the skid resistance. The treatment of corners resulted in improved texture and a substantial improvement in skid resistance.

In 1997 there remains evidence of the improved surface texture resulting from the original treatment.

Photograph showing the change in texture caused by the hydro jetting treatment - Friendship Square, Cheltenham North.

At the trial sites in Williamstown Road, Port Melbourne and Friendship Square, Cheltenham, the skid resistance improved from an SFC (Sideway Force Co-efficient) of about 0.25 to greater than 0.70 immediately following the treatment.
