Technical Note

Pavements in Poor Condition

TN 109

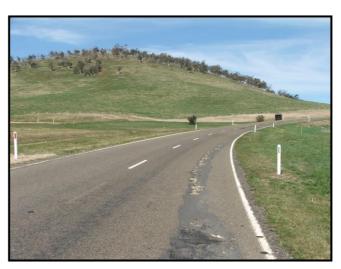
Figure 1. Significant number of potholes.

<u>Potholes</u> – a significant number within a short area. Refer Figures 1 and 2. These areas have a history of potholes occurring between the routine maintenance inspections.

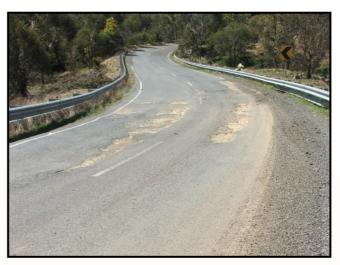
Figure 2. Significant number of potholes.

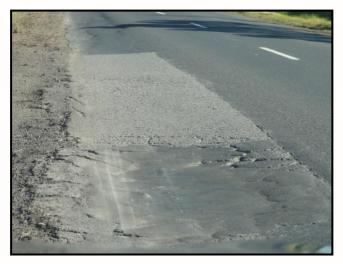
Figure 6. Significant failed area with loose pieces of pavement.

<u>Failed pavement areas</u> – significant/extensive failed pavement which affects the ride quality or vehicle stability, or results in pavement material becoming dislodged. Refer Figures 5 and 6.

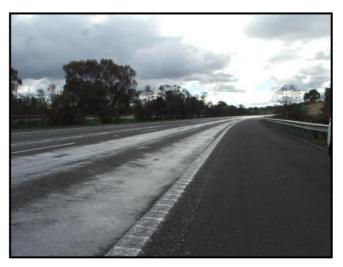
Figure 7. Significant flushed wheelpaths in a 100kph zone.

Flushed sites are sites that provide low skid resistance. A flushed site can be assessed as a pavement in 'Poor Condition' as a result of the safety impact it may have on road users. Extended lengths (greater than 50 metres) of slick surfaces in both wheel paths may affect road user safety. Refer Figures 7 to 9 for examples. The assessment of sites where concern has been raised regarding the level of skid resistance should be assessed in accordance with Technical Note 110 (Measurement and Interpretation of Skid Resistance Using SCRIM)
