Testing Times

Issue 15

December 2002

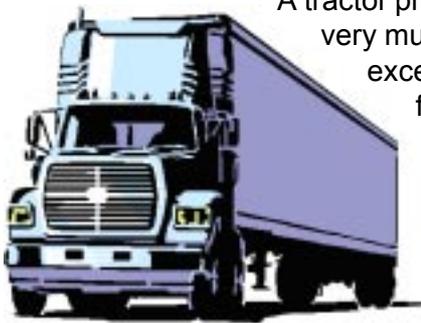
Tractor Protection Valves are not mandatory on heavy vehicles equipped for towing but some means of ensuring that a towing vehicle with air or vacuum assisted brakes will retain its brake performance if the trailer breaks away or the trailer brake system fails is mandatory. Tractor protection valves are probably the most common means of doing this but they are not the only means. For example, the tow vehicle may be fitted with a separate air supply system for the trailer (including the control line supply) with a priority system to ensure its own needs are met first.

A tractor protection valve is very much like an excess flow valve fitted to LPG fuel systems. If the pressure on one side of the valve drops suddenly the valve will shut off

immediately. But just like the LPG excess flow valve, a small bleed across the valve is provided to enable it to reset.

So how do you check that the protection system, whatever it is, works? Pulling out the trailer air or vacuum couplings and testing the tow vehicle brakes is no good as many couplings are self-sealing anyway.

What you need are suitable couplings (preferably with a short piece of open ended hose attached for ease of handling) that you can plug into the tow vehicle couplings (supply and control) to simulate broken lines. Once these are plugged in with the engine stopped and all air flow has stopped (other than the small bleed flow if a tractor protection valve is used) check that the tow vehicle's brakes do actuate properly.

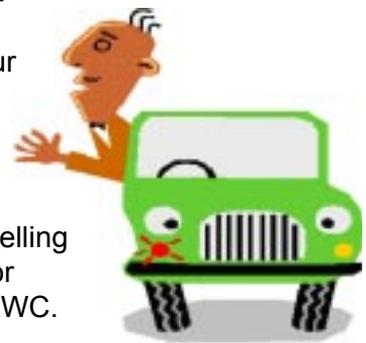
The steerable front wheel on a motorcycle is more for balance than going round corners and very little steering lock is applied in all but the slowest of turns. In fact the front wheel is often turned slightly the opposite way in sweeping corners to compensate for the steering effect of leaning the bike over. This may be why motorcycles are not usually fitted with simple self-cancelling turn signal switches - they may never self-cancel anyway.

While turn signals that self-cancel are extremely convenient and they come as standard on most four wheeled vehicles, because self cancelling is not mandatory so the absence of self-cancelling cannot be grounds for refusing to issue a RWC.

However, it would be wise to note their absence or failure on the test report, as a service to the owner, because it is an offence to leave a turn signal operating after completing a turn.
