Road Structures Inspection Manual 2022

Road Structures Inspection Manual - 2022

Department of Transport's (DoT) Road Structures Inspection Manual

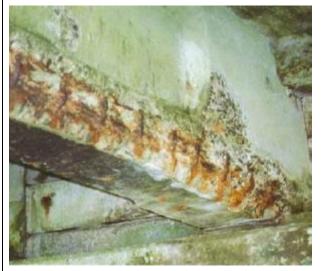
- Delaminations, spalls and corrosion of reinforcement are prevalent with loss of reinforcement section greater than 20%.
- Exposed stressing strands may have corrosion up to 10% of their cross section or some strands may have broken.
- Heavy cracking or failure of the anchorages may have occurred. Heavy flexural cracking may be present in the beams or in the deck above the supports.
- Severe spalling may have occurred due to corroding reinforcement or at the ends of the beam at the bearing areas.

Severe spalling along bottom of beam with corroding reinforcement.

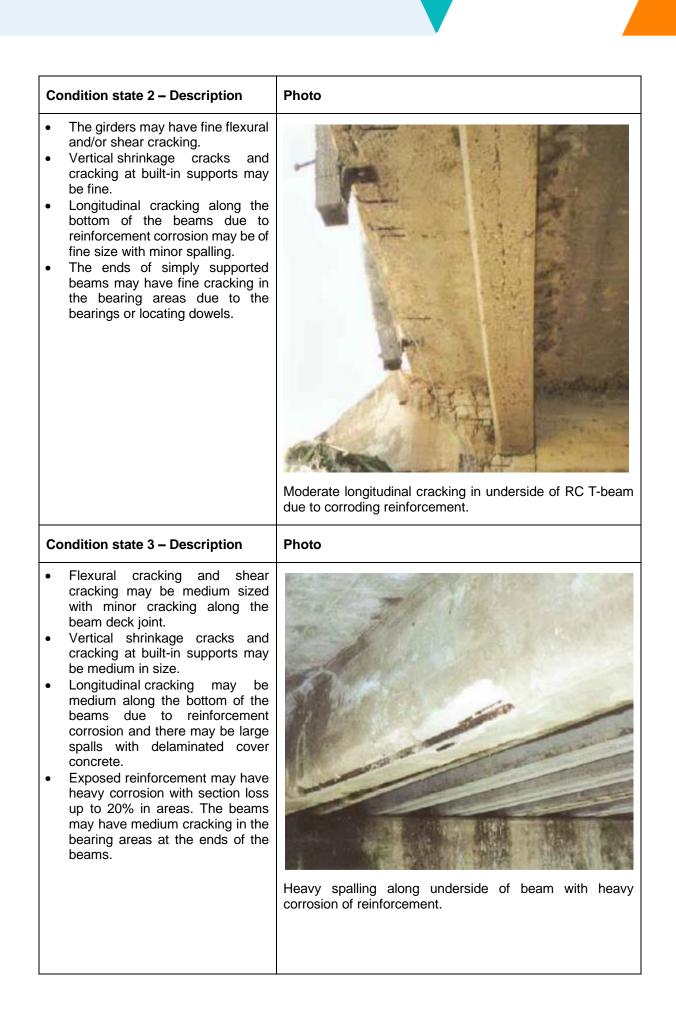
Condition state 1 – Description	Photo
 The girders have minor fine cracking due to corroding reinforcement but there should be no shear cracking or spalling of the concrete. Hair line cracking may exist at the built-in supports or fine vertical shrinkage cracks may appear in the beams due to the locked up movements of the structure. 	Variable depth cast-in-situ RC T-beams in good condition with diaphragm bracing at quarter points of span.

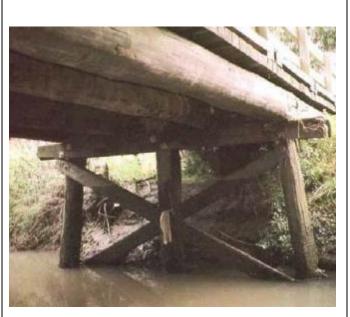
- The stringers are in good condition with little or no pipe rot or decay.
- There may be minor splits or checks having no effect on member strength.
- Glued laminated beams have no separation of the laminations and no splits or checks within the laminations.

Timber stringers in good condition with no splitting or sap rot of outer timber.

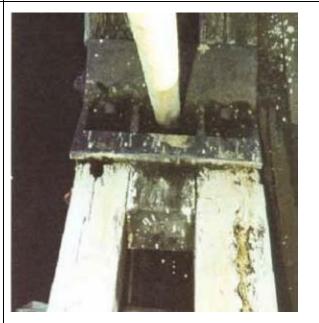
- Decay, splitting, cracks and checks are producing loss of strength of the members especially at the joint where there may also be crushing of the members.
- Joint connections may be a little loose but only having minor effect on the serviceability of the truss.
- Lateral bracing of the truss at the top may be poor or ineffective allowing the trusses to move laterally under load.
- Accident damage to the trusses may have a minor effect on the stiffness of the trusses or strength of some members.

Rot, splitting and weathering of timber diagonals and lower truss chord.

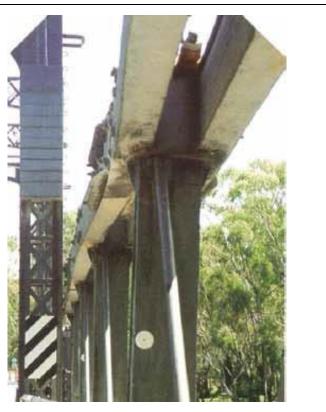
- Decay, splitting and crushing has produced significant loss of strength in some members which affect the serviceability of the truss.
- Lateral bracing of the top of the truss is completely ineffective and the top chord may have a large lateral bow in it.
- Accident damage to the truss is a major concern affecting the strength of the members and the truss.

Truss has a large bow in the top chord and vertical members are leaning.

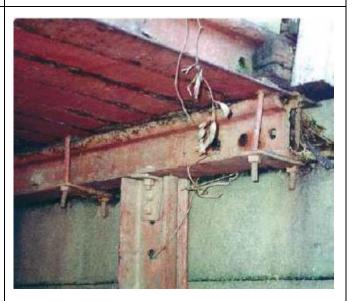
- Photo
- There may be fine transverse cracks in the infills at midspan but no longitudinal cracking along the rail/concrete interface.
- The rails may be quite rusty but no pitting or corrosion is occurring.
- Distributor rails may be slightly loose or there may be minor cracking and spalling of the concrete encasement.
- The deck is not deflecting excessively under load.
- If thin cover concrete has been cast under the rails then heavy spalling of the cover concrete will occur when the rails rust. This is only of concern when the cover concrete begins to disintegrate in the bearing area.

Minor corrosion of the rail especially at the ends of deck.

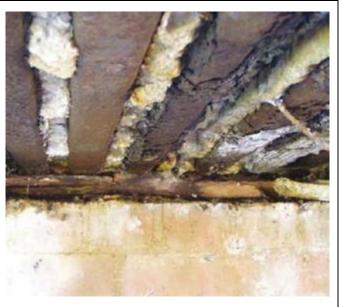
- Heavy cracking, spalling or crumbling of the infill concrete is occurring with loss of strength and lateral distribution. Consequently the deck is deflecting excessively under load.
- The rails may be heavily pitted and corroded. Distributor rails will possibly be very loose or have broken away.
- If the rails only have concrete up to the head of the rail, the outer rails may separate from the deck as bond is lost between rail and concrete.
- These bridges have much reduced capacity due to lack of lateral distribution.
- Holes may be found as concrete is pushed through the deck.
- Steel steps may be broken and require replacement or re-welding.
- Steel deck plates may be very loose and buckled requiring replacement

Steel rails heavily corroded and concrete infill cracked and breaking up.

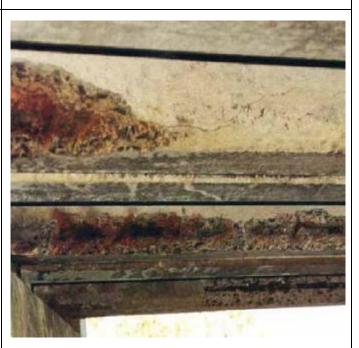
- The shear key concrete between the high strength U-Slabs may be badly cracked and sections may be broken out.
- U-Slab bolts will be loose, many with nuts completely missing, or they may have been retightened and badly cracked the top of the slab.
- There may be heavy cracking and spalling of the U-Slab legs with heavy corrosion of the reinforcement with section loss of 20% or greater.
- There may be heavy cracking of the ends of the U-Slab legs due to badly positioned bearings.

Severe cracking and spalling of U-slab legs due to chloride ingress corroding the reinforcement.

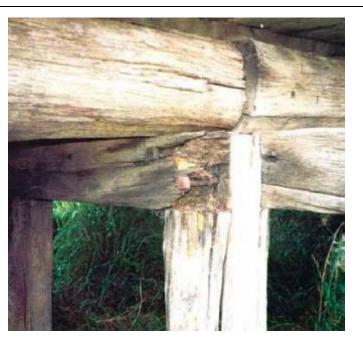
- The crossheads may be heavily decayed, weathered, severely split or cracked, and may have crushing at the supports.
- Large sagging may be evident under RSJs and the crosshead may have moment cracking.
- Bolted connections may be completely loose and the crossheads may have pulled off or almost pulled off the supporting piles.
- Crosshead splices may have broken apart with loading on the unsupported cantilever crosshead section.

End of crosshead rotten and stringer now basically supported on pile only.

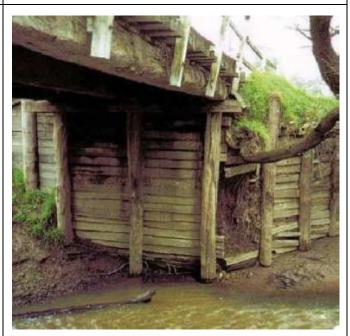
- Timber units may be severely decayed and whole areas may have rotted out or been eaten out by white ants.
- Loss of embankment fill or wingwall fill is occurring due to earth pressure or the material is being lost due to water wash at the base of the abutment or wingwalls.
- Wingwalls may be in a state of collapse due to rotted supporting piles.
- Concrete fender walls may be severely cracked and broken allowing heavy loss of embankment fill material.

Rotted out timber sheeting, collapsed sheeting and washout of embankment filling behind the abutment.

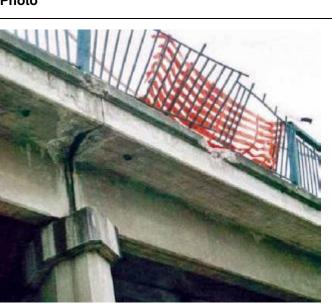
Severe accident damage with loss of railing.

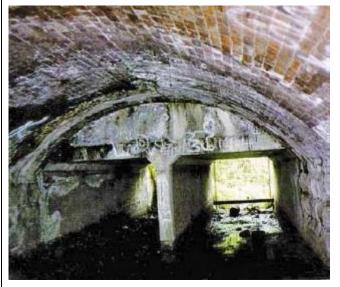
Heavy cracking in roof of brick arch culvert and excessive white efflorescence powder visible due to dampness penetration.

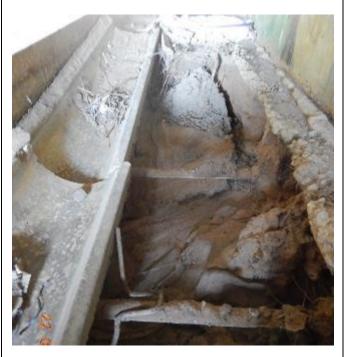
Channel with vertical settlement between components causing loss of drainage system effectiveness. Erosion has exposed reinforcement in reinforced soil block and is severely affecting the strength and serviceability of the retaining wall.

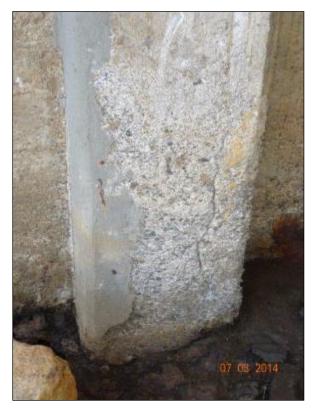
Figure 1.1.2.3. Waterwash

Water wash is caused by water borne sand and gravel particles eroding the concrete surface.

Water wash of a concrete column is shown in Figure 1.1.2.3.

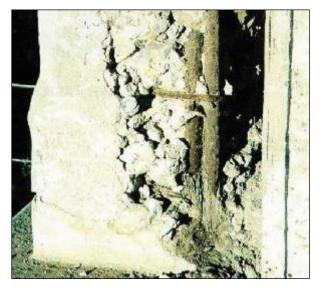
Figure 1.1.2.4 (a) Corrosion of reinforcement in concrete

Corrosion is the deterioration of reinforcement by the process of oxidation. Corrosion can also occur in the presence of high Chloride ion concentration such as when the concrete is immersed in sea-water or exposed to salt-spray. Corrosion may appear as a rust stain on the concrete surface initially. In the advanced stages, the surface concrete above the reinforcement can crack, delaminate and spall-off exposing the underlying reinforcement. This process is illustrated in Figure 1.1.2.4 (a) & (b)

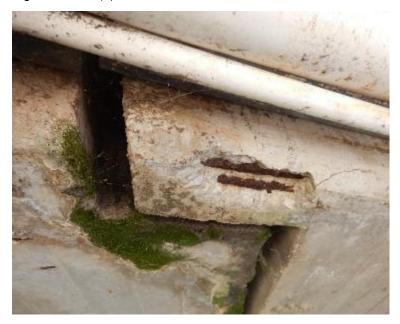
Figure 1.1.2.4 (b) Corrosion of reinforcement in concrete

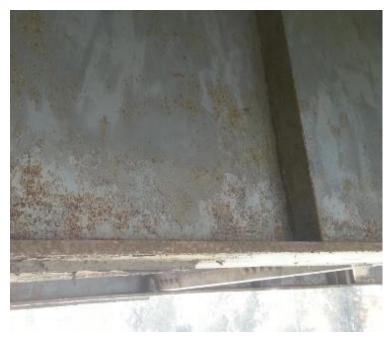
Figure 1.1.3.1 (a) Light corrosion on steel work and loss of protective coating

Light corrosion can be identified as small reddish brown spots and occurs on steelwork when the existing protective coating is loss.

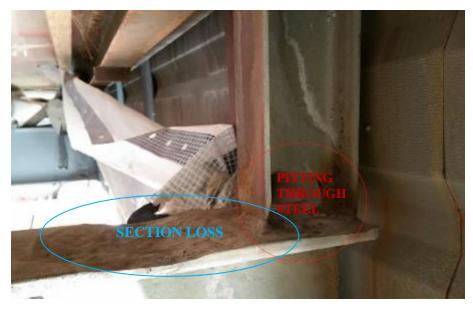
Figure 1.1.3.1 (c) Section Loss and Pitting Through Steel

Pitting corrosion can be identified as holes and cavities and is caused by localised corrosion. This generally progresses from light corrosion spots on steelwork or is due to localised water ponding or exposure.

Section loss can be identified as uniform area of steelwork with noticeable cross sectional loss. This may occur when the section of steel work has lost its protective coating exposing the steel surface area to environmental conditions.

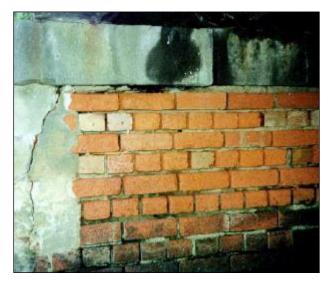
Figure 1.1.5.3 Loss of mortar.

Loss of mortar is the result of water wash, plant growth or softening by water containing dissolved sulphates or chlorides. Partial disintegration of mortar may lead to loss of stone blocks.

Figure 1.1.5.3 shows evidence of loss of mortar.

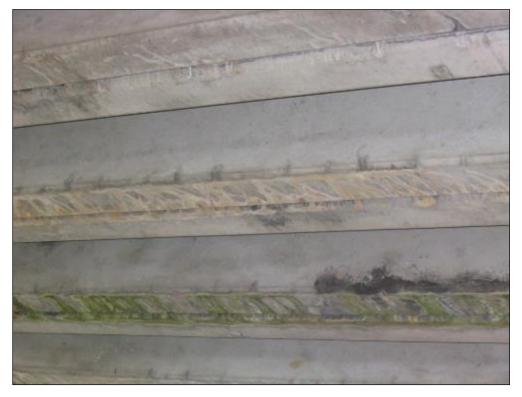
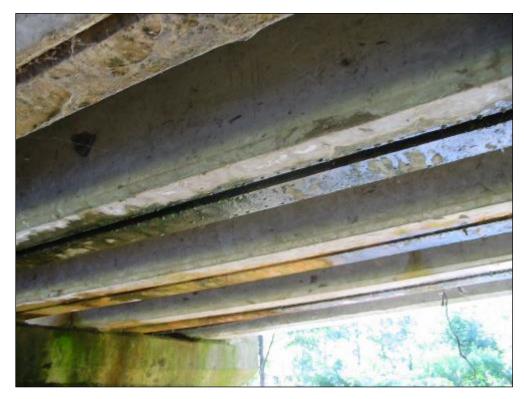
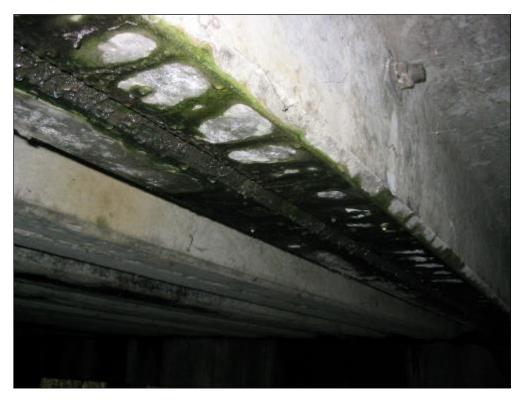
Figure 1.2.1.9.3.2 (a) Water leakage/Staining

Refer to Figure 1.2.1.9.3.2 (a), (b) & (c) for examples of the different ratings for each category.

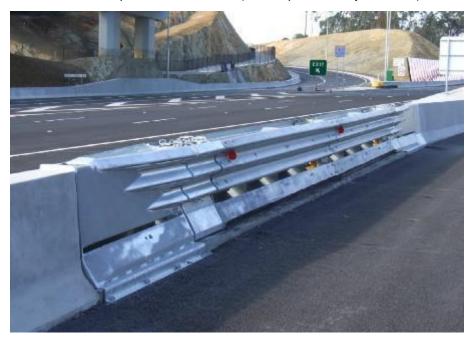
Figure 1.2.9.5: Typical Ironman Gate System (legacy installation)

Problems with legacy installations include:

- Difficulty removing locking pins.
- Difficulty manually moving gates and hinge side plates.
- Debris build up under rubber skirt (can be permanently removed).

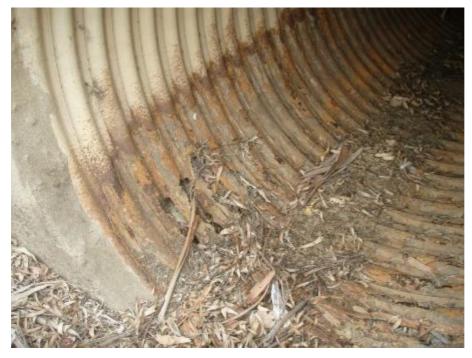
Figure 1.18.1 SN8616 Bulleen Road

BCMS inspected on the 13th December 2006 by SW Consultants P/L and found to be unsafe for concrete lining unless it is propped. The upper limit of corrosion-affected metal on the water-side is clearly visible.

Locations to inspect include the splash zone, invert of the BCMS, overall shape of the structure checking for degree of rusting, section loss (holes) and deformation. Refer Figure 1.18.1 and 1.18.2 for examples of BCMS corrosion.

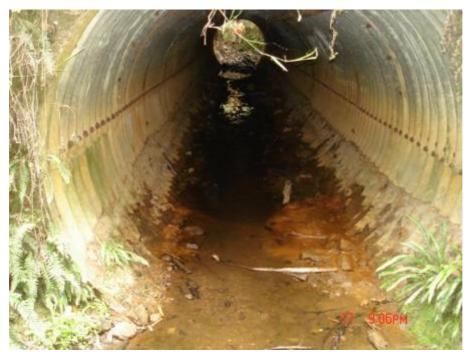
Figure 1.18.2 Warburton/Woods Point Rd, Brahams Creek

The invert in this case has corroded away and water is flowing below the original invert level. The upper limit of corrosion-affected metal on the water-side is clearly visible.
