Technical Note

Rock Slope Routine Maintenance

TN 36

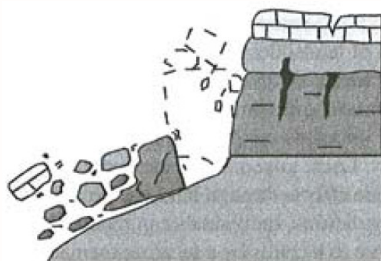
Figure 1: Toppling failure.

The type and orientation of defects in the rock mass control the development of toppling failures, sliding failures and wedge failures. Defects are naturally occurring discontinuities within the rock mass and include bedding planes, joints, shear zones, weak seams and faults. An adverse combination of defect orientations and rock cut batter orientation allows the above failure mechanisms to develop on rock cut batters.

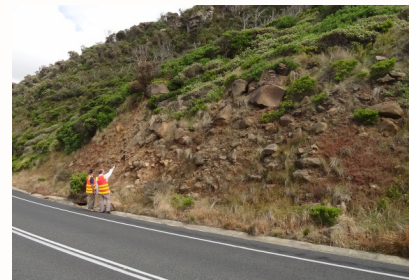
Figure 4: Loose rocks on batter face.

Poor constructions practices, predominantly from prior to the 1970's, are often the cause of loose rocks on batter faces. Blasting was more common in this period and traditionally was uncontrolled, resulting in shattered rock cut batter faces with open joints and undercut rock blocks. Contemporary ripping and rock breaking may have a similar effect if uncontrolled. Design rock cut batter slopes in this period were typically 0.75:1, resulting in overly steep batters. Contemporary design rock cut batter slopes are desirably 3:1 and a maximum of 2:1 unless a site specific design is undertaken.

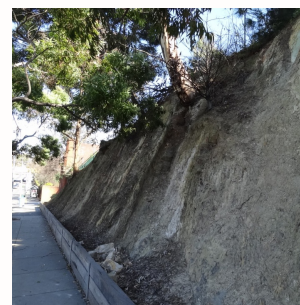
Figure 5: Root jacking.

Trees are the cause of root jacking. The roots of trees growing on rock cut batters grow into defects, expanding and jacking out rock blocks from the rock cut batter face. Trees are not planted on rock cut batters, and any trees growing on rock cut batters are self sown. Trees on rock cut batter slopes steeper than 2:1 are inherently unstable, and will fall towards the road. Tree falls on natural slopes above roads can also trigger rockfalls consisting of loose boulders.

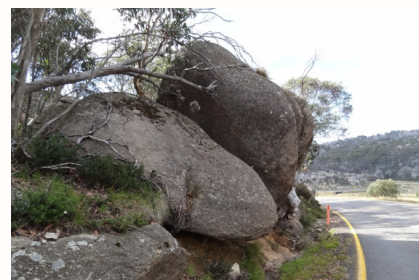
Figure 6: Loose boulders on natural slope.

Rainfall is typically the cause of rockfalls consisting of loose boulders on natural slopes above roads. Rainfall reduces the friction between

boulders, and also saturates and reduces the shear strength of any soil underlying boulders, causing this failure type. Rainfall can also trigger all other common rock slope failure mechanisms when it falls directly on rock cut batters, flows over rock cut batters from the natural slope above, or flows through culverts outletting on rock fills.

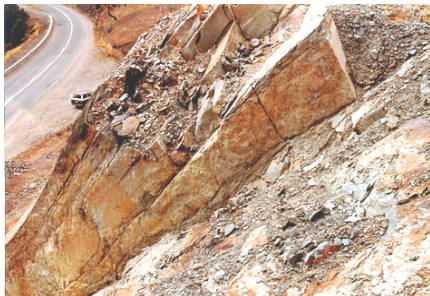
Figure 7: Weathering and adverse defect orientations.

Weathering can cause toppling failures and loose rocks on batter faces. Weathering is a natural effect that turns rock into soil, and occurs faster in defects than the rest of the rock mass. Weathering of joints results in the formation of loose rock blocks between joints, and weathering of weak seams creates undercut rock blocks on rock cut batters.

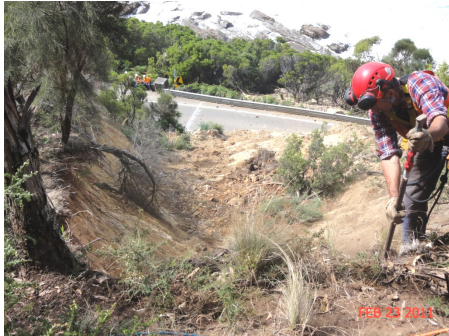
Figure 8: Scaling.

Scaling consists of the removal of loose rocks from rock cut batter faces and loose boulders from natural slopes above roads. Scaling is only undertaken where one or more of the following characteristics are met:

Scaling is undertaken using hand held, non-mechanical equipment e.g. pinch bars, crowbars, rakes, shovels, picks etc. Hand held, mechanical equipment such as pneumatic jacks or jackhammers are only used in extenuating circumstances, and excavators and explosives are not used under any circumstances.

Scaling of rock cut batters is undertaken over the full height of rock cut batters, and requires the use

of elevated work platforms or aerial rope workers for access.

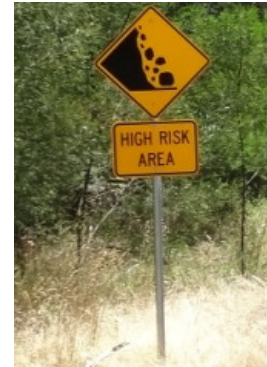
Figure 9: Rockfall warning sign.

Rockfall warning signs are installed in accordance with the VicRoads Traffic Engineering Manual Volume 2.2 Part 2.2 page 103-104. Rockfall warning signs are only installed at sites with an assessed risk level of HIGH or VERY HIGH, and consist of a left or right Fallen Rocks symbolic sign and High Risk Area supplementary sign installed on both approaches to the site.

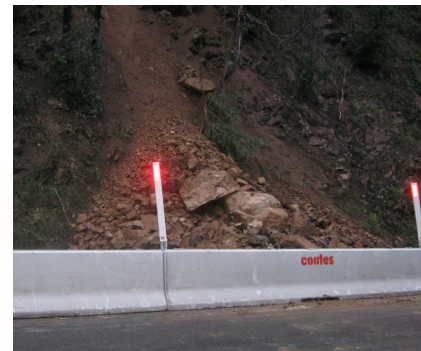
Figure 10: Temporary rockfall catch fence.

Temporary rockfall catch fences are constructed in emergency situations from concrete or steel longitudinal safety barriers. These barriers are installed in accordance with VicRoads Road Design Note RDN06-04 and in conjunction with other traffic management as required by the *Road Management Act 2004 Worksite Safety – Traffic Management Code of Practice*.
