## Small Roller Overturn- Potential Operator Containment Risk

# Safety Alert

November 2015

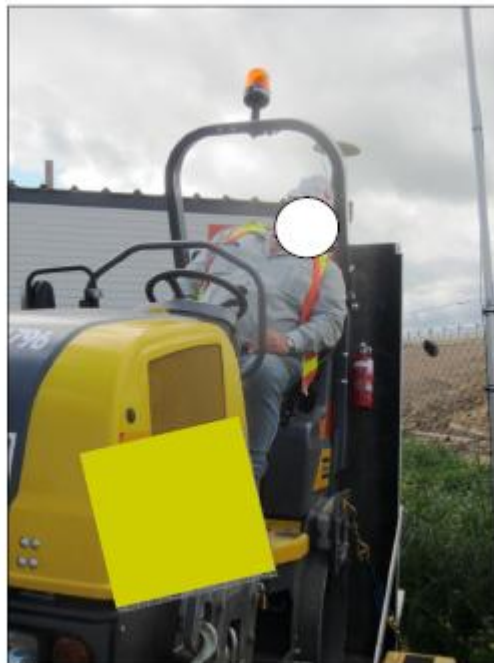
- Strike their head on the ROPs or ground when the roller overturns;
- Their torso and limbs could extend outside the protected area provided by the ROPs particularly if the machine were to roll completely over such as could be possible on high batters.

**Potential for operator to strike head on ROPs.**

Rollers which confine operators within the machine so their body cannot protrude outside the frame of the machine during an overturn should better protect operators. This is particularly important during road works near high batters where a machine could roll a number of times. Larger machines with cabins are usually used on larger size road works and better confine operators, but with open doors operators can and have been ejected during overturns involving full roll-overs when they were not wearing their seat belt.

Seat belts must be worn to prevent the operator being ejected from the machine as per the OHS Regulations.

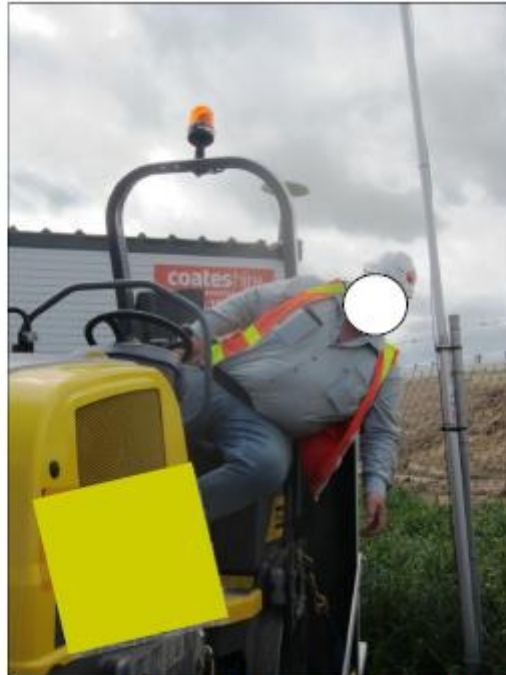
**Head, torso and arm well outside of roller with seatbelt worn.**

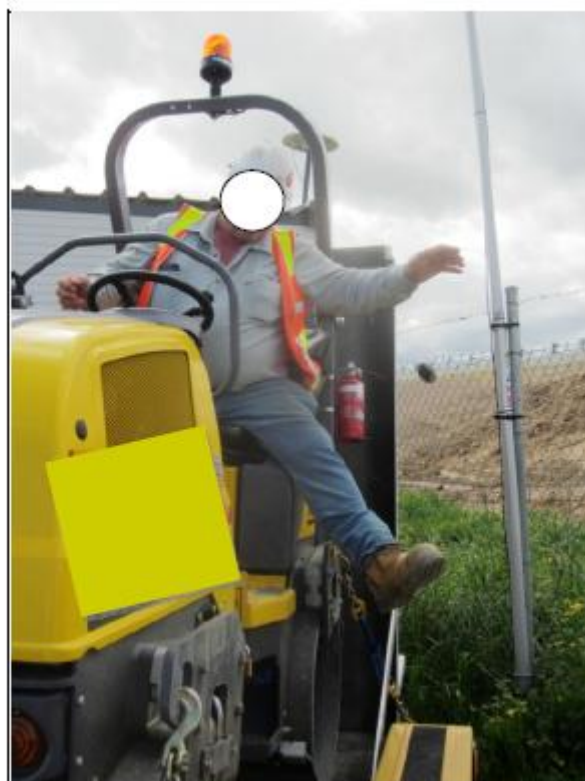
**Arms and legs could protrude outside roller.**
