REDUCING REFLECTION CRACKING OVER JOINTED CONCRETE PAVEMENT

The purpose of this Technical Note is to disseminate information gained from a 10 year old VicRoads trial which experimented with a number of treatment methods aimed at reducing reflective cracking over a jointed concrete pavement. The rigid pavement on the Western Highway in Braybrook had minimal differential movement between the slabs and was overlaid with asphalt to improve ride quality.

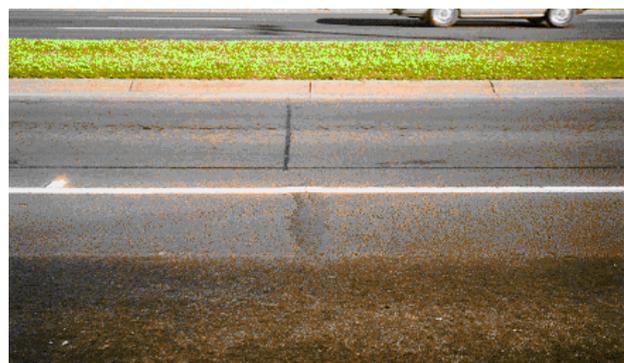
Transverse cracking in "saw cut and seal" joints. Note the reflective cracking does not extend into the BSRA section (foreground).

- saw cutting the asphalt surfacing (to about 60% of the depth) directly above the joints in the concrete slabs and filling the saw cuts with polymer modified bitumen. This treatment has resulted in 2% to 3% of the treated joints cracking after 5 years with no further cracking noted after ten years service.

The joint treatment that was most effective was to saw cut the asphalt immediately above the joint in the concrete pavement and fill the saw cut with polymer modified bitumen. It is believed that this was most effective because it controlled the cracking by concentrating it at the saw cut, thus preventing spalling of the joint.
