TREATING PAVEMENTS SUBJECT TO COMPLEX PRIOR TREATMENTS

This Note reports on the outcomes of the research and provides discussion on the issues pertinent to the treatment of these surfaces.

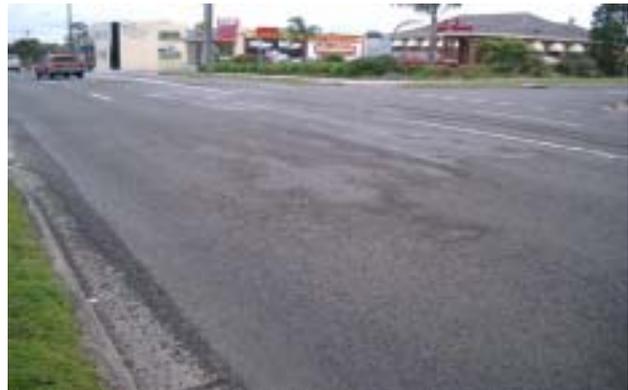
This material is often open in its grading (similar to OGA) and its failure mechanism is frequently associated with ravelling, either due to brittle, oxidized binder or the shearing stress associated with turning or braking traffic (Figure 1).

Figure 1 Ravelling of UTA

In some cases ravelling of the UTA has resulted due to high stresses imposed by braking, turning and accelerating traffic. These areas are often best retreated with dense graded asphalt or stone mastic asphalt.

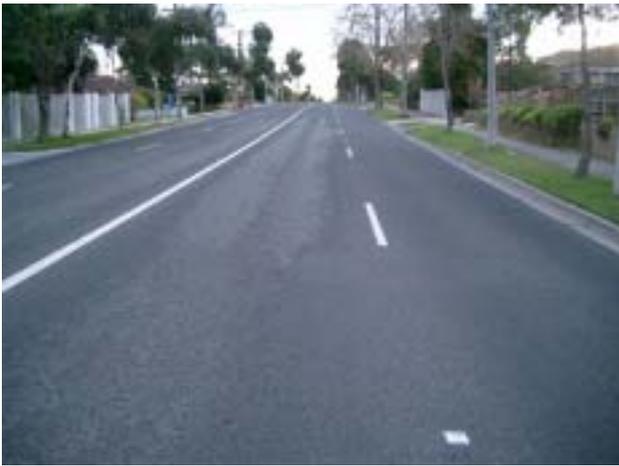
- Application of a spray seal surfacing will need to consider drain down of the sprayed seal binder and the possible existing variable surface texture. There is a likelihood that poor performance of the seal will result in stripping (Figure 2) from binder drain down or flushing due to less binder drain down than anticipated.

Figure 2 – Stripping of a spray seal applied to UTA.
