TOP DOWN CRACKING IN MELBOURNE PAVEMENTS (MAINTENANCE OF THICK ASPHALT PAVEMENTS)

Whilst the performance of thick asphalt pavements has been widely reported overseas, only limited investigation has been undertaken in Victoria to determine how thick asphalt pavements constructed in Melbourne since the 1970s are performing and the types of distress they are exhibiting. This Technical Note provides guidance for pavement maintenance based on the outcomes of R&D Project No 951 Top Down Cracking in Melbourne Pavements.

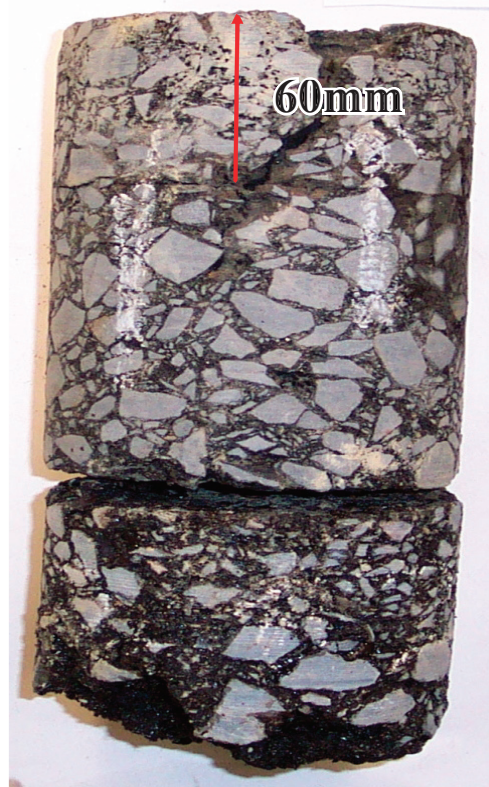
Figure 1 Example of extent of cracking and condition of underlying asphalt.

The investigation has shown that 3 out of 4 of the sites investigated generally exhibited behaviour expected of ‘long-life’ pavements. (See Figure 1).

The project basically demonstrated cracking generally was limited to 40 to 60mm from the top of the pavement provided:

- An investigation of the pavement cracking prior to any removal and replacement program. Undertake coring to confirm the asphalt depth (if not known from records) and depth of cracking;
- If the pavement depths are greater than 210mm then this R&D project has found in 3 out of the 4 sites, cracks are in the surface, rather than deep seated cracks (to the subgrade), coring will confirm this;
- Patching of cracked pavements involving the removal and replacement of large depths of asphalt pavement material, is not necessary;
- Consider crack sealing, as the first option, to ensure the surface is water tight and delay the propagation of the crack; and
- If and when patching is required depths can be limited to 40-60mm, without being detrimental to the performance of the asphalt pavement.

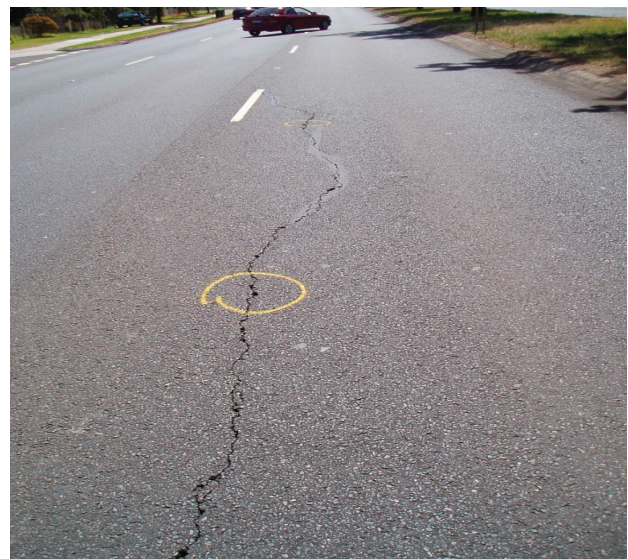
Figure 2 Surface appearance of the sites inspected.

Note: no vertical displacement across the crack.
